High School/Middle School:

HS Roof 13 – Boys Locker room

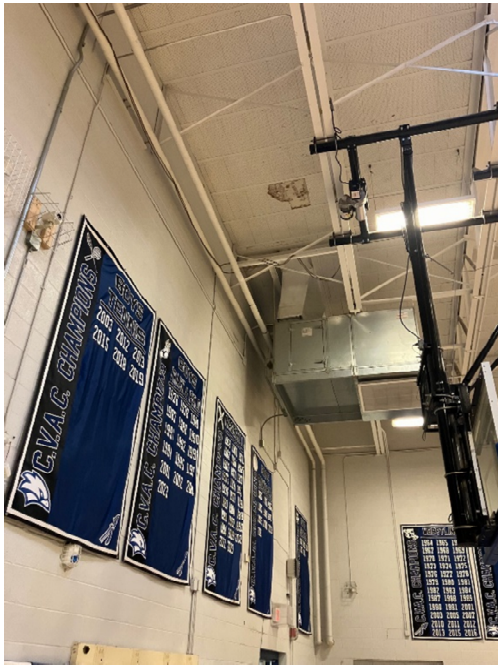
HS Roof 18 – Stained Ceiling Tile

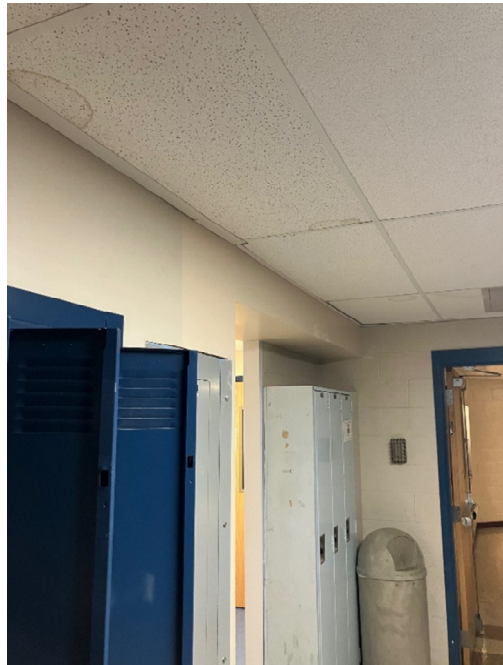
HS Roof 26 – Stained tiles

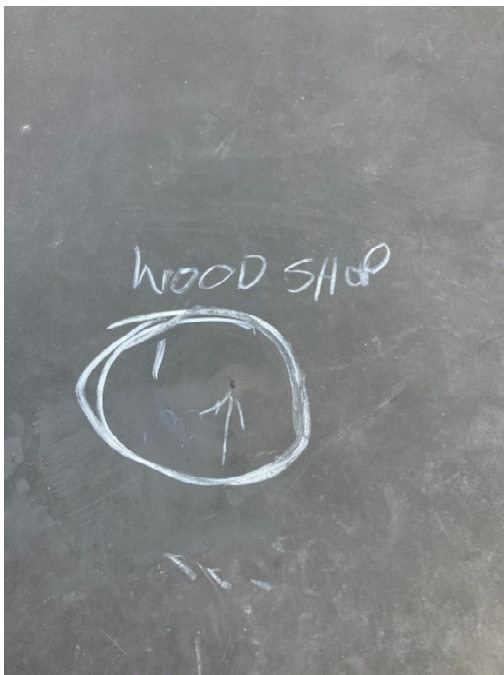
Exterior EPDM roof puncture

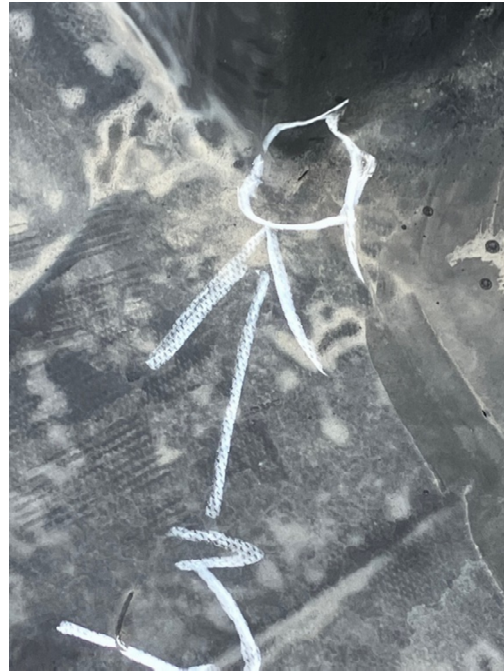
Roof Curb Flashing Failure

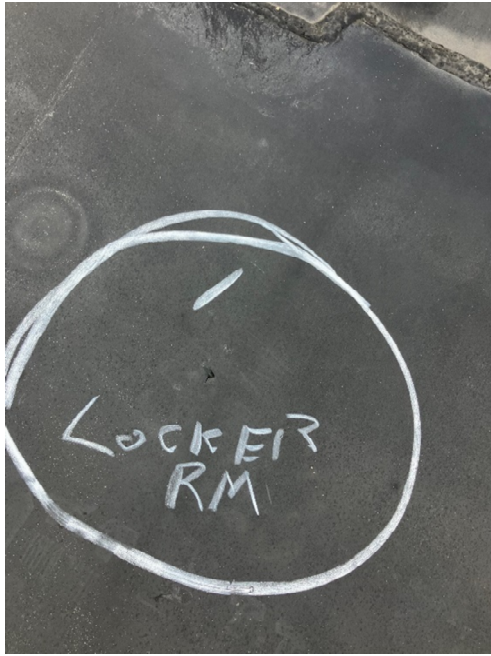
EPDM Roof Membrane Punctures

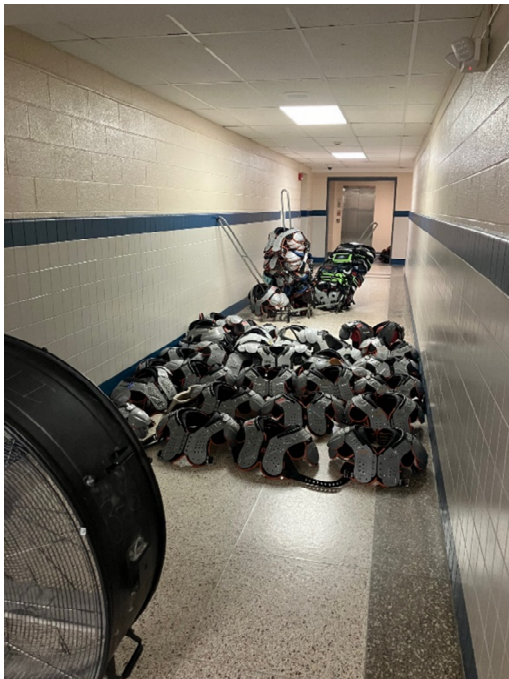
Football Pad Drying after roof leak

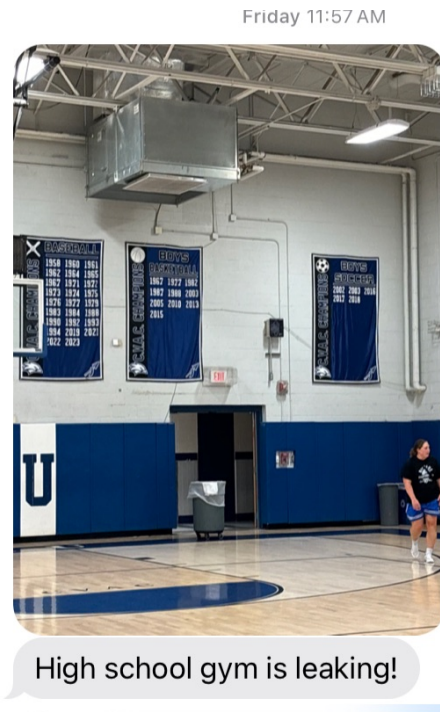
High school Gym. Trash can to catch roof leak water

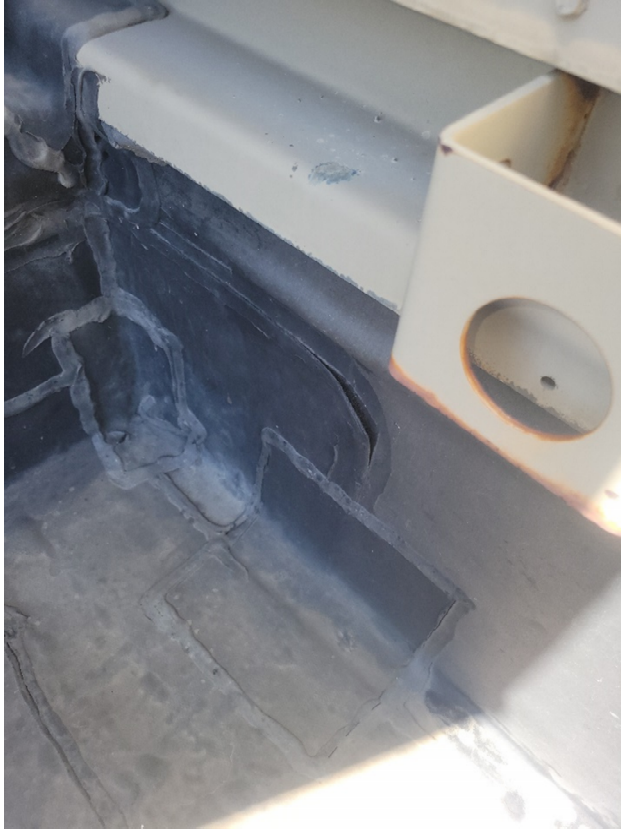
MS Gym Roof 1 flashing failure

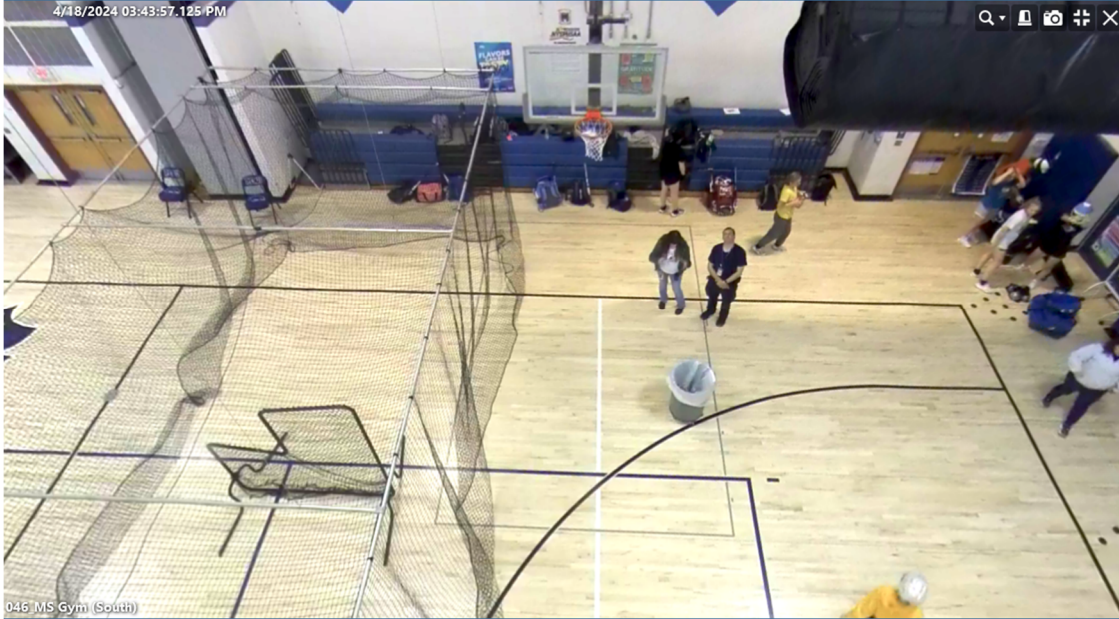
Trash Can to capture water leaking from roof.

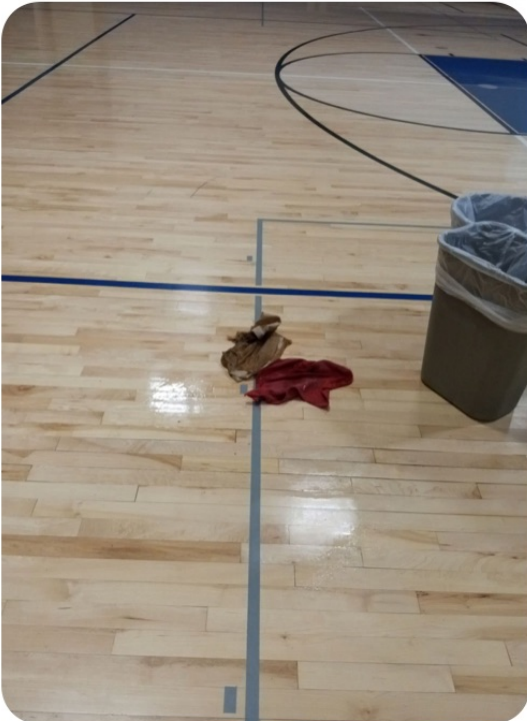
I got a mop and will put the buckets there

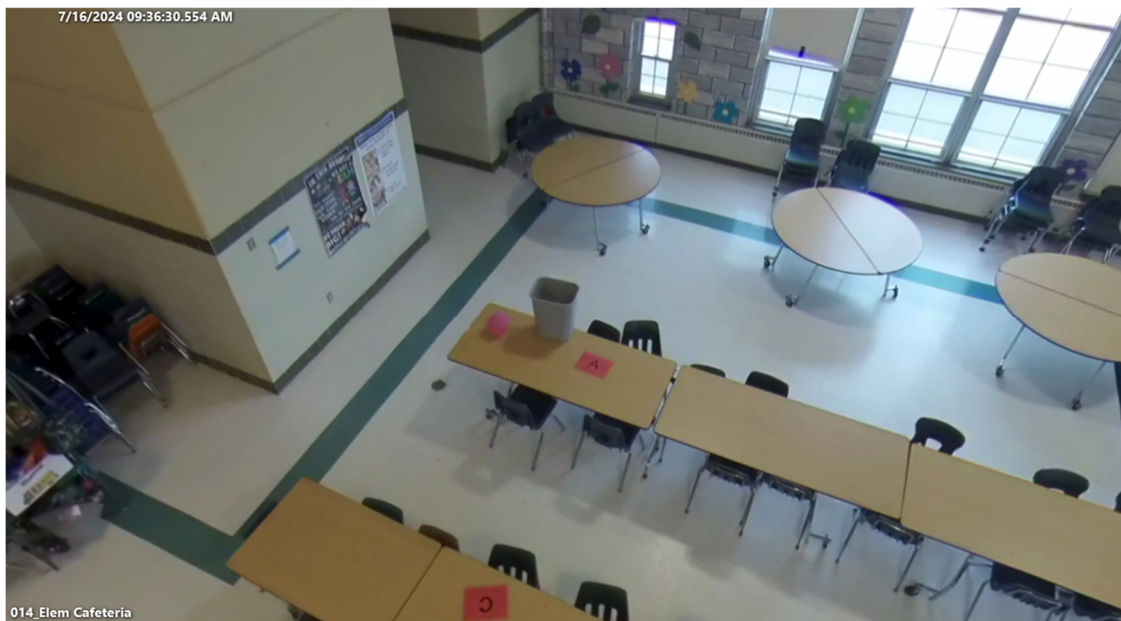
Elementary Café water leak

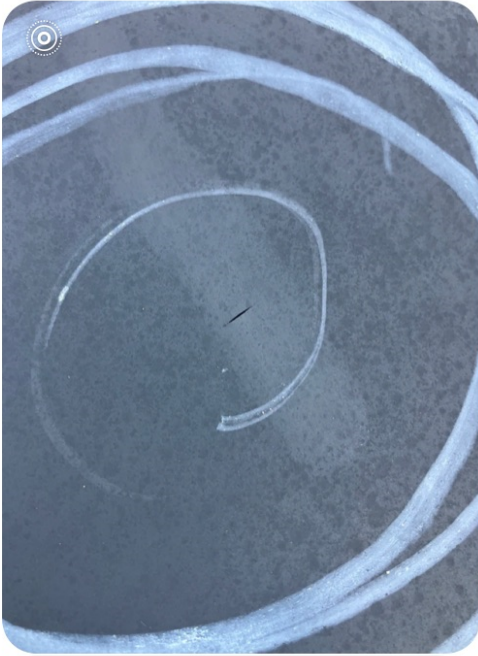
Think I found the leak above
primary cafeteria

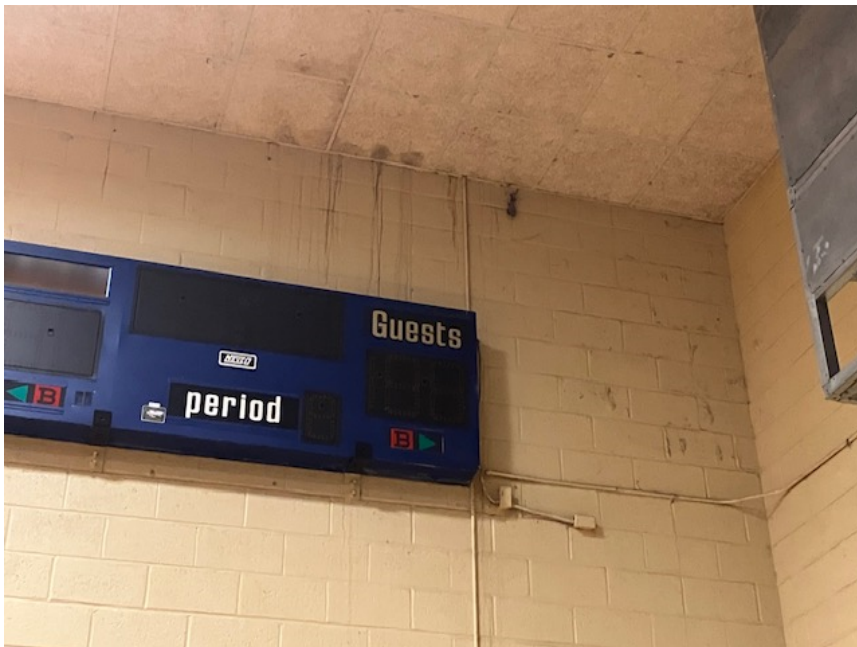
Intermediate Gym roof 19 Roof Leaks

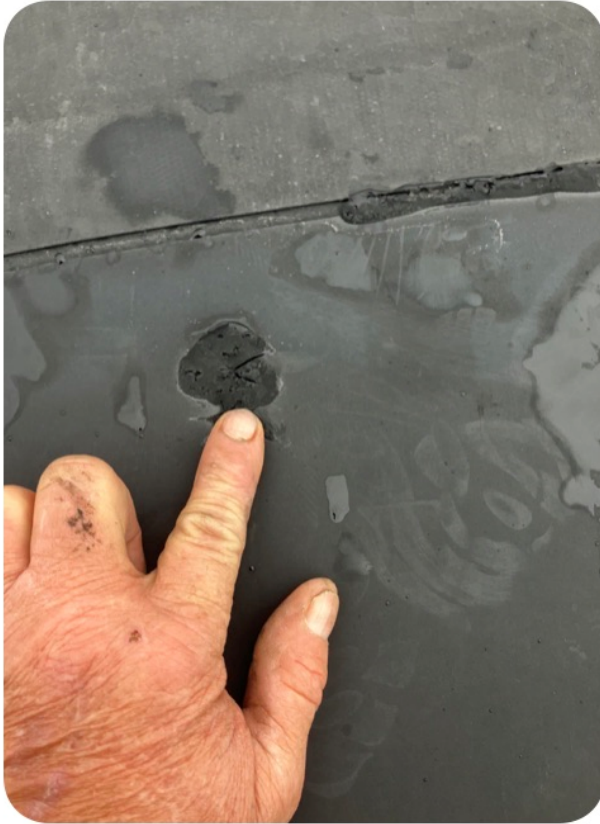
There is the boys bathroom
leak

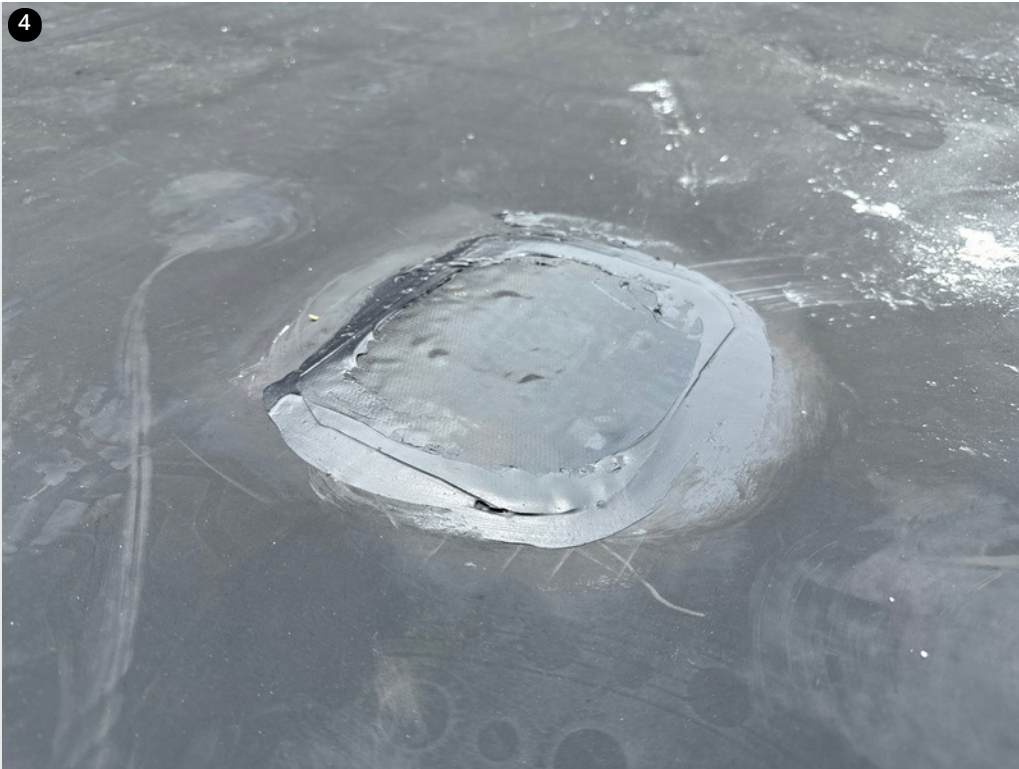
Properly repaired core cut with additional structural caulking for protection

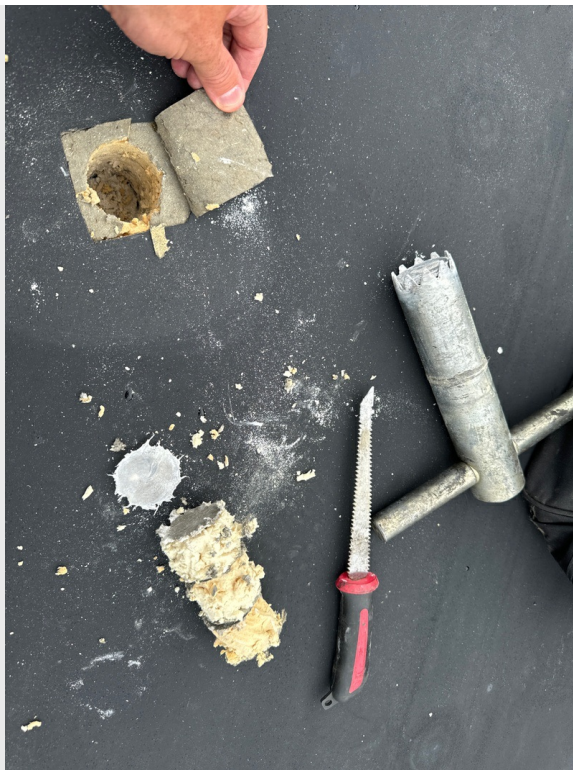
Core cut on roof number 13 was totally dry 4 to 6 inches of insulation and a poly vapor barrier over a gyp or lightweight concrete deck

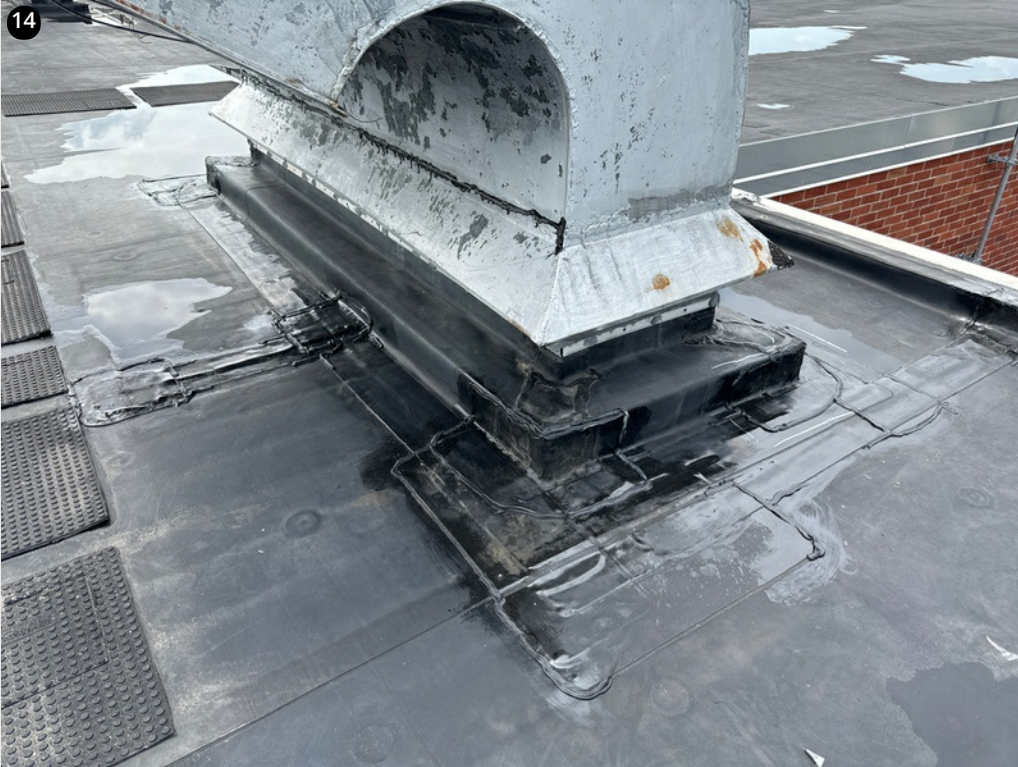
This old vent has clearly had quite a few issues and has been repaired multiple times

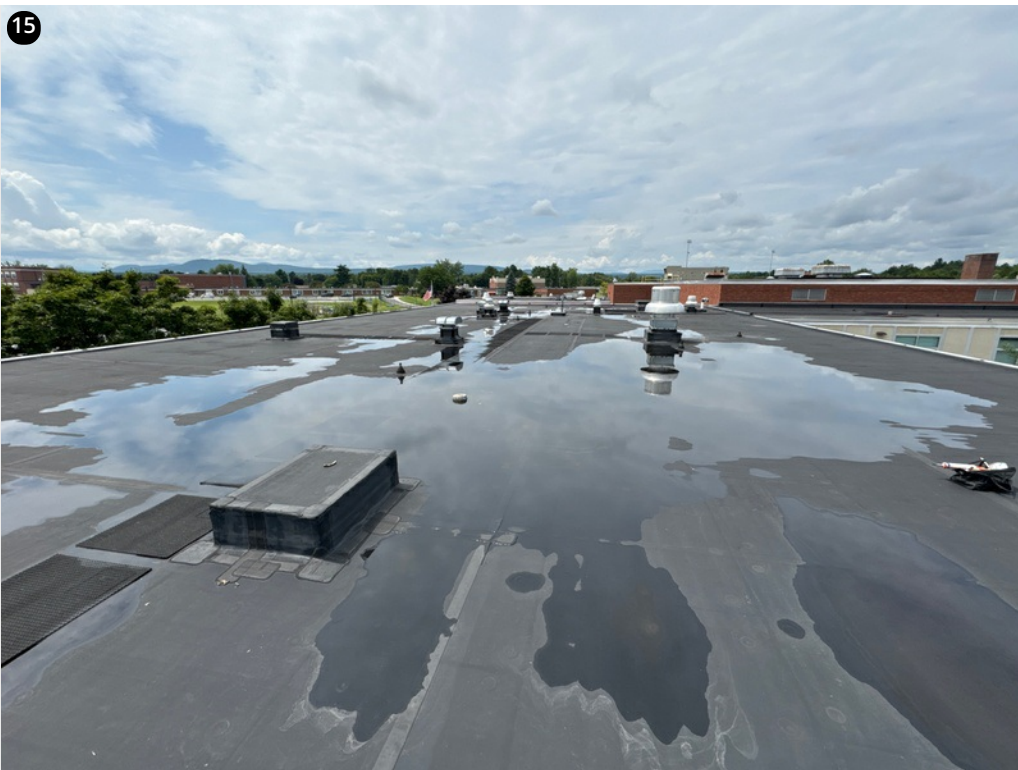
View of large ponding water area on roof number 26 the drain is clogged and needs to be kept clean

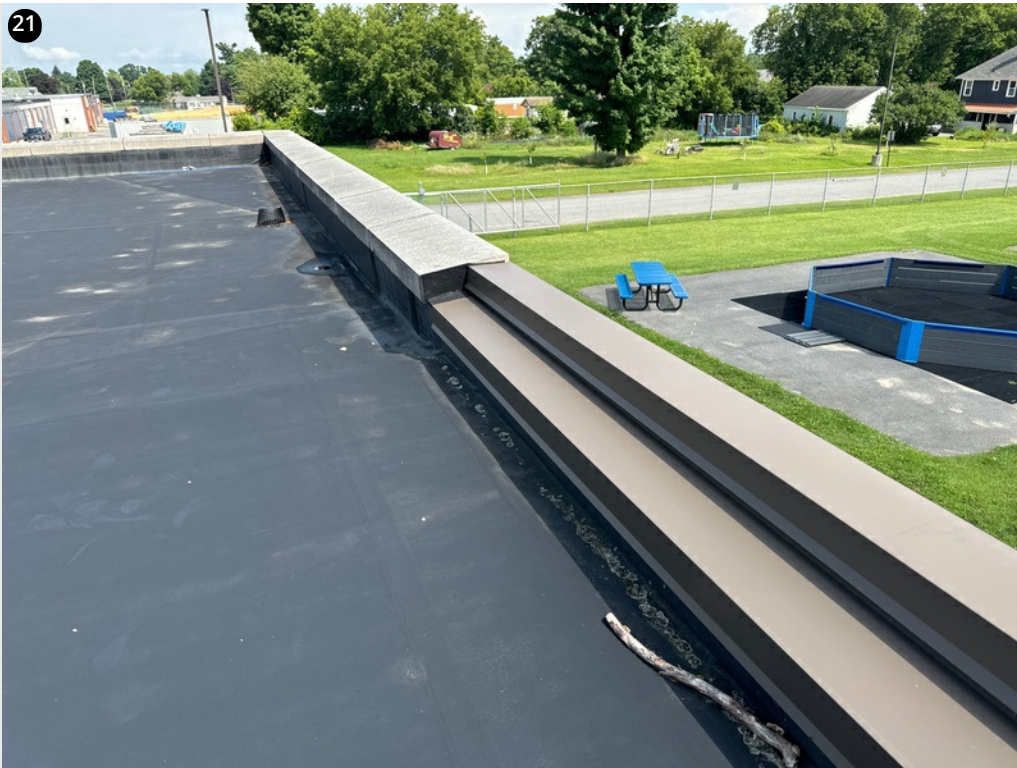
Roof section one has a newly installed multi layer metal coping where roof section 2 has old concrete cap stones

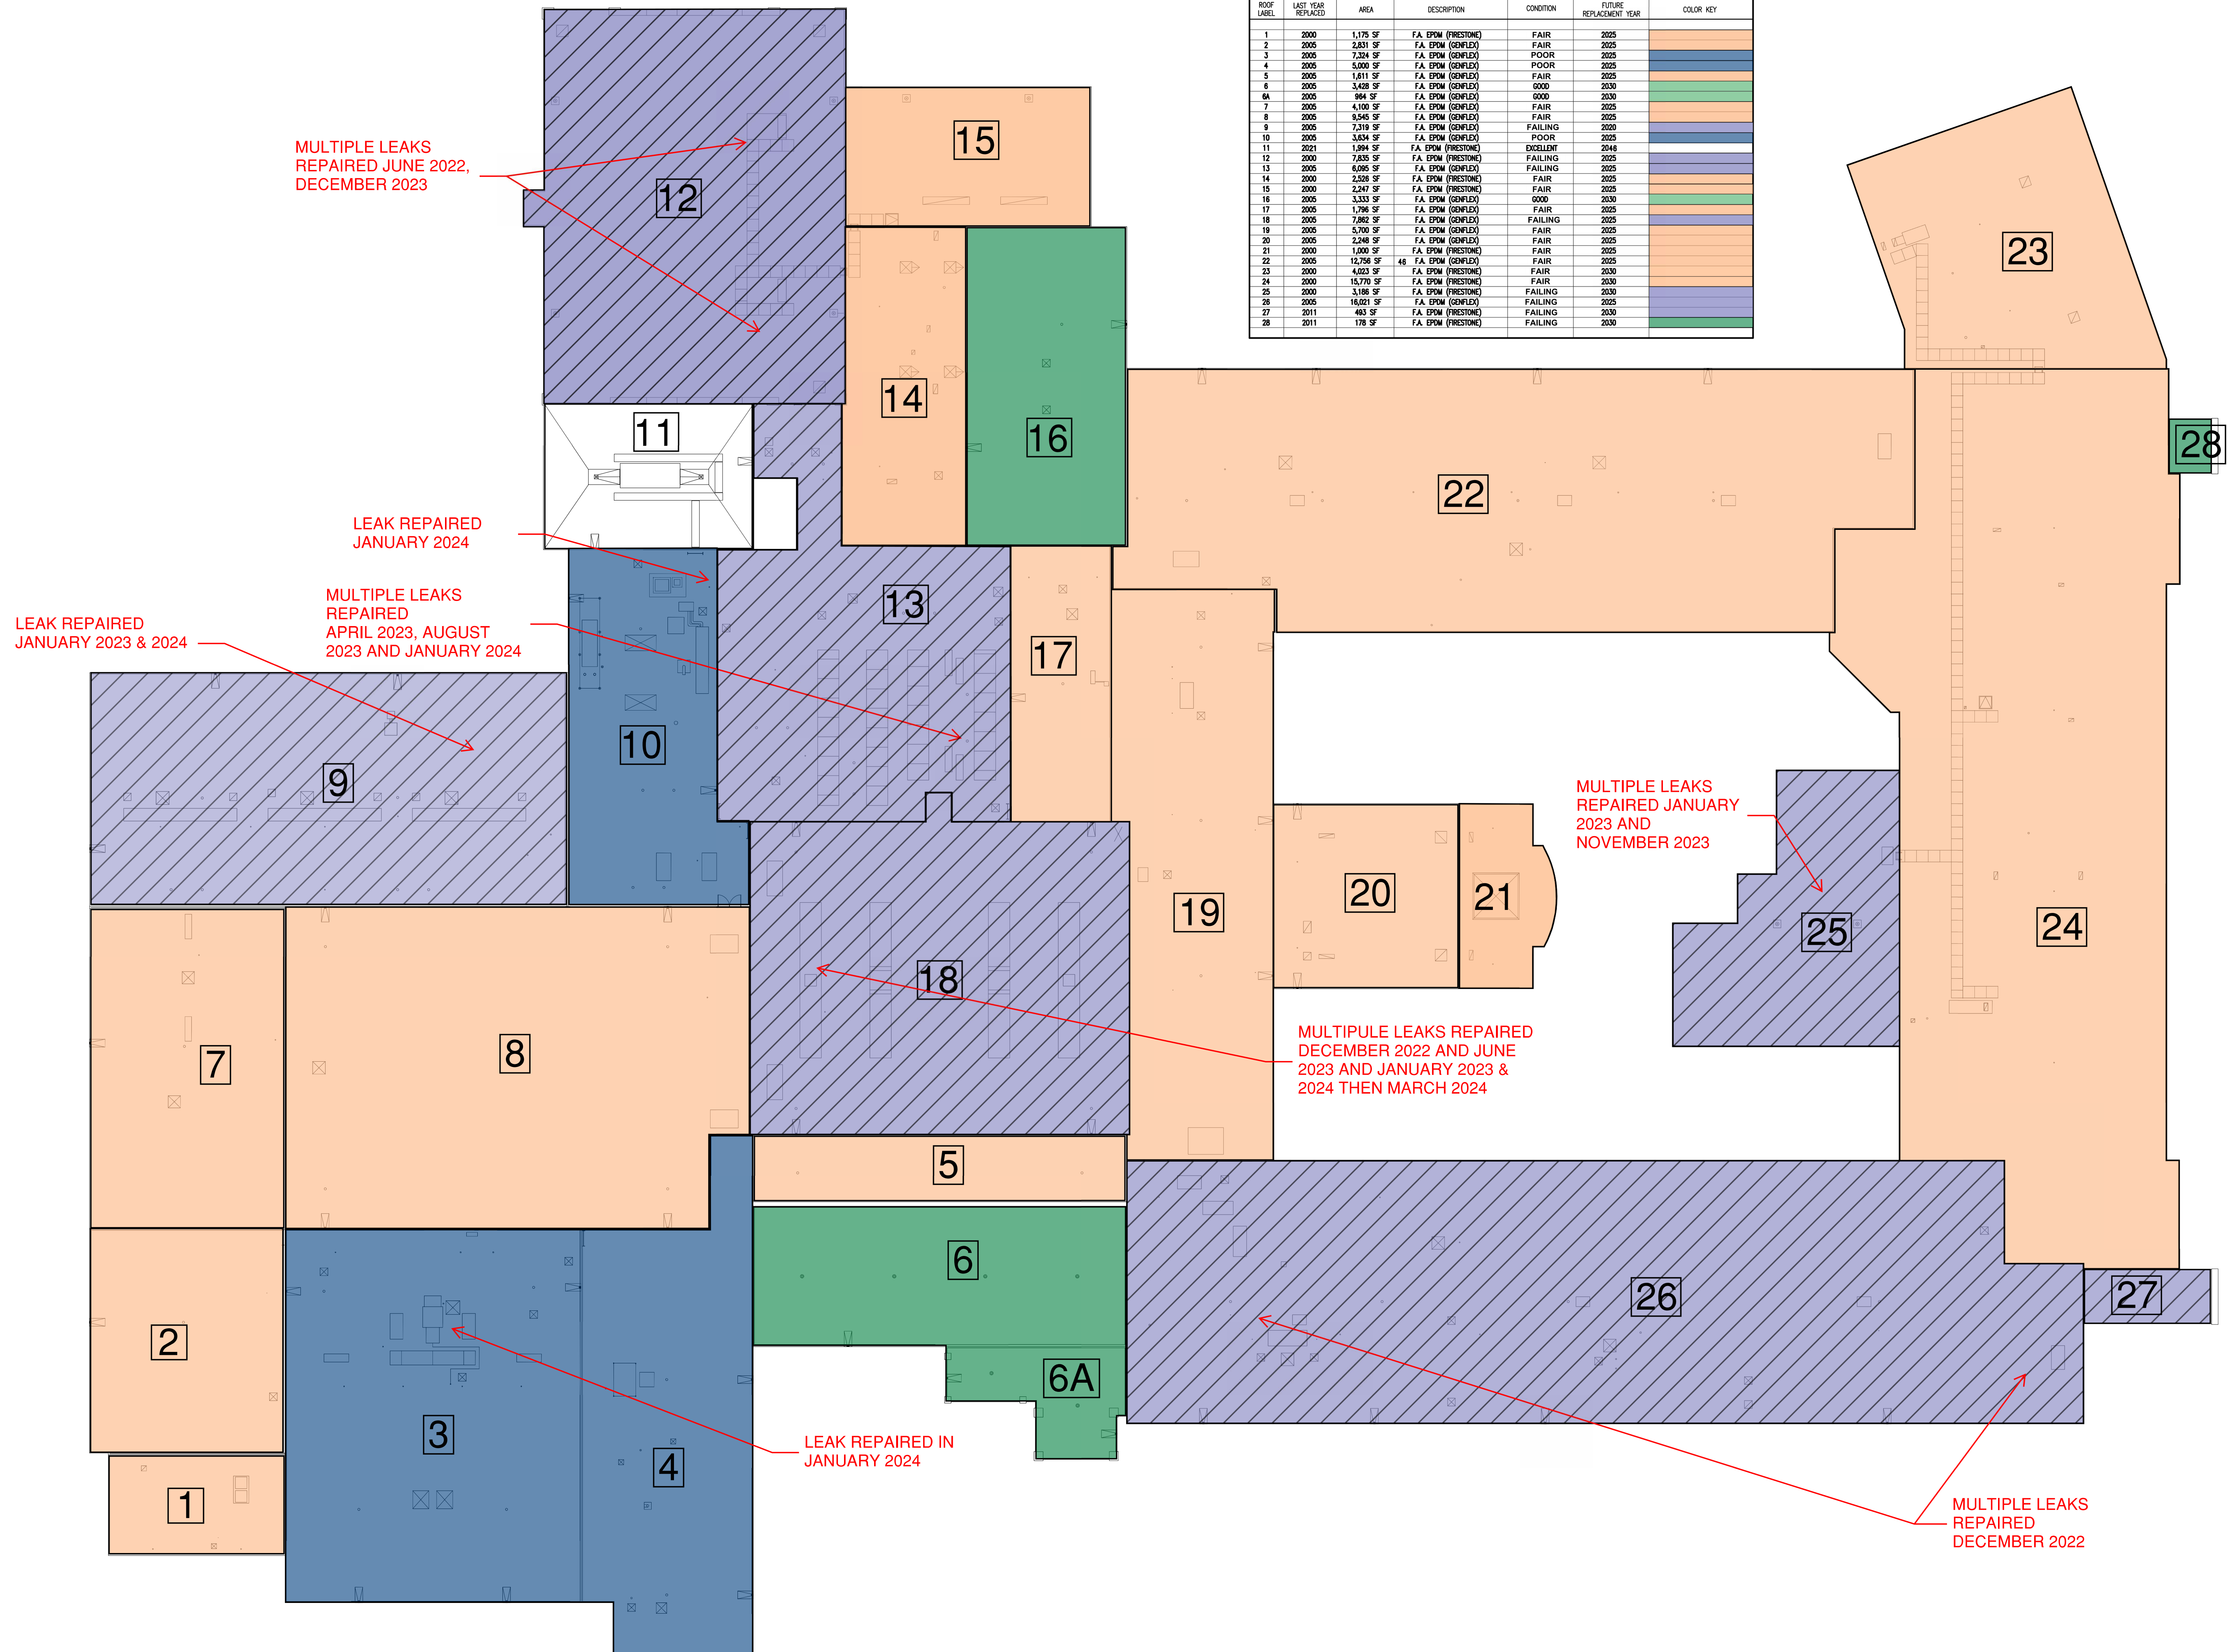
17	2005	1,796 SF	F.A. EPDM (GENFLEX)	FAIR	2025	
18	2005	7,882 SF	F.A. EPDM (GENFLEX)	FAILING	2025	
19	2005	5,700 SF	F.A. EPDM (GENFLEX)	FAIR	2025	
20	2005	2,248 SF	F.A. EPDM (GENFLEX)	FAIR	2025	
21	2000	1,000 SF	F.A. EPDM (PRESTONE)	FAIR	2025	
22	2005	12,258 SF	46 F.A. EPDM (GENFLEX)	FAIR	2025	
23	2000	4,023 SF	F.A. EPDM (PRESTONE)	FAIR	2030	
24	2000	15,770 SF	F.A. EPDM (PRESTONE)	FAIR	2030	
25	2000	3,186 SF	F.A. EPDM (PRESTONE)	FAILING	2030	
26	2005	16,621 SF	F.A. EPDM (GENFLEX)	FAILING	2025	
27	2011	483 SF	F.A. EPDM (PRESTONE)	FAILING	2030	
28	2011	178 SF	F.A. EPDM (PRESTONE)	FAILING	2030

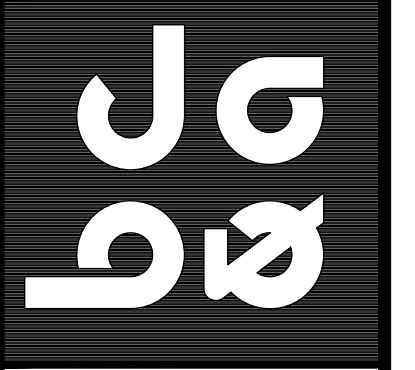
ROOF PLAN & SCHEDULE
 PERU CENTRAL SCHOOL DISTRICT
 ROOF CONDITION REPORT
 PRIMARY INTERMEDIATE SCHOOL
 Town - County - State of New York
